The H1 Central Silicon Tracker: Performance and Upgrade

Benno List

VERTEX 2001

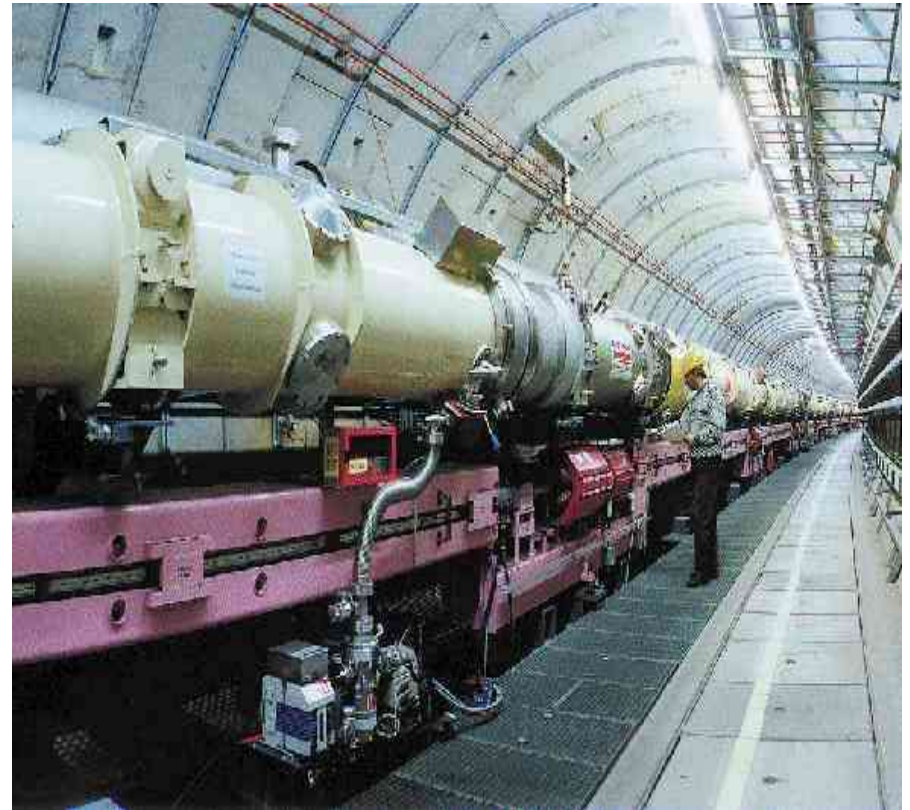
Introduction: HERA

- " ep-Collider at DESY
- " 50 mA Electrons at 27.5 GeV
- " 100 mA Protons at 920 GeV
- " »Worst of both Worlds«
 - Synchrotron radiation:
 - " Radiation problem itself
 - " Heats the beampipe
 - 4 kHz/m proton gas collisions
- " Bunch spacing
96 ns = 1/10.4 MHz •

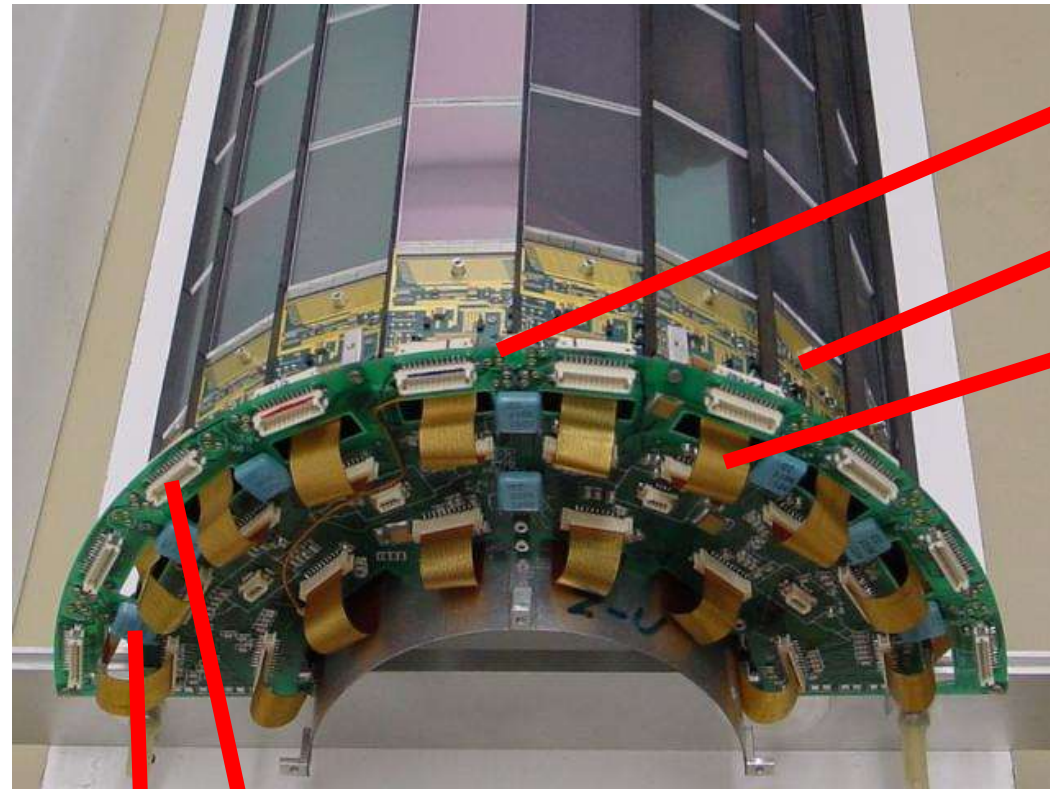
Endring Prints

Endring Print:

Distributes signals and power

Readout Hybrid

Capton Cable

Sender for analog readout●

Power Connectors

Filter Capacitors

Receiver for steering signals

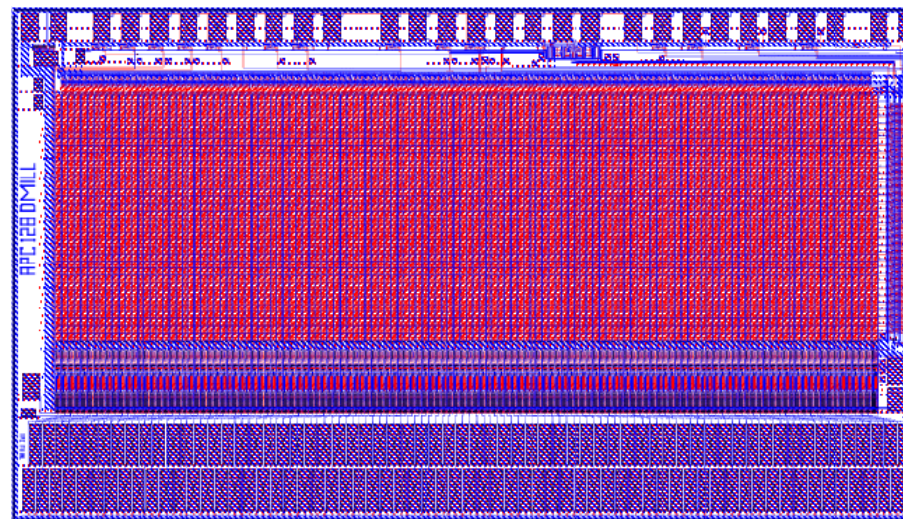
" APC128: Analog Pipeline Chip

128 Channels

32 stage analog pipeline

Buffers data at $>10\text{MHz}$

Serial readout at 2.5 MHz

$6.4 \times 3.8\text{mm}^2$

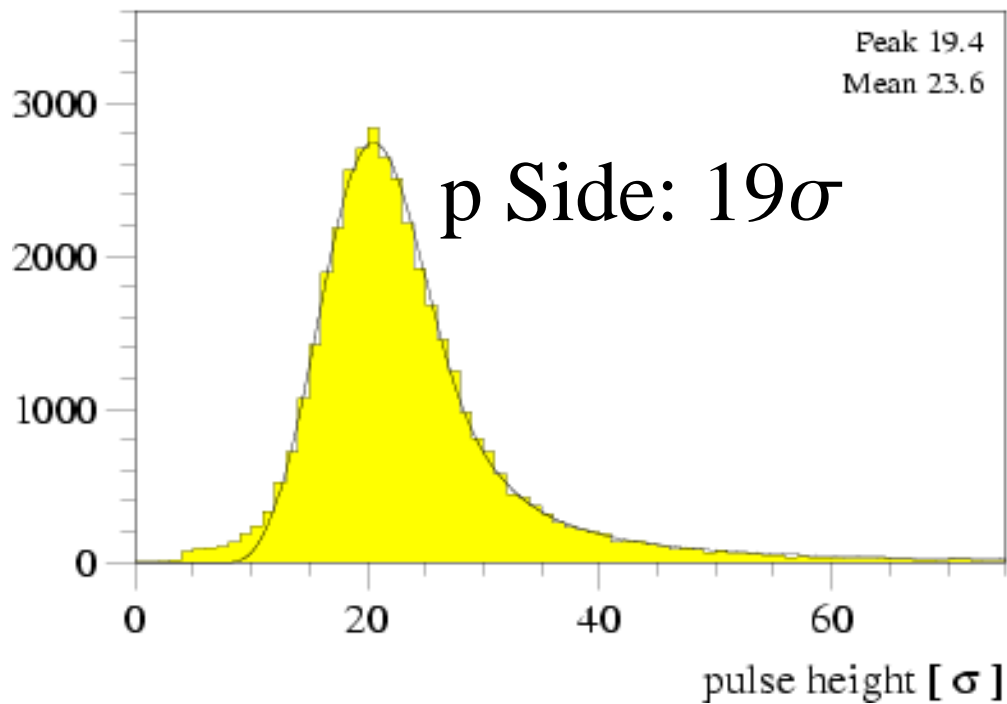
Signal/Noise: Measurement from penetrating cosmics

Total signal, divided by mean single strip noise

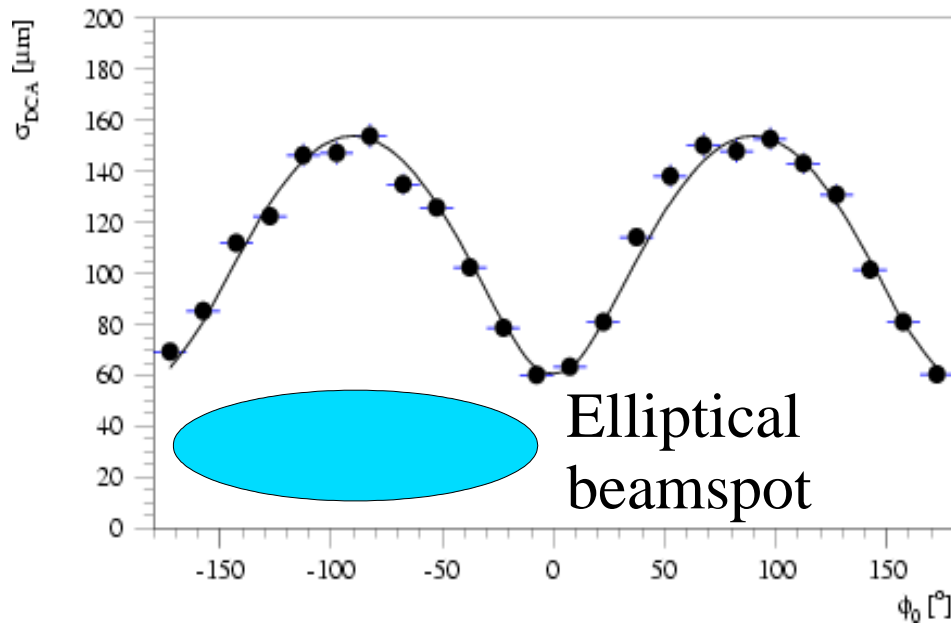
Width of impact parameter distribution as measured with the CST as function of φ .

A fit gives:

"Beamspot width: 155 μm

"Impact parameter resolution: 54 μm .

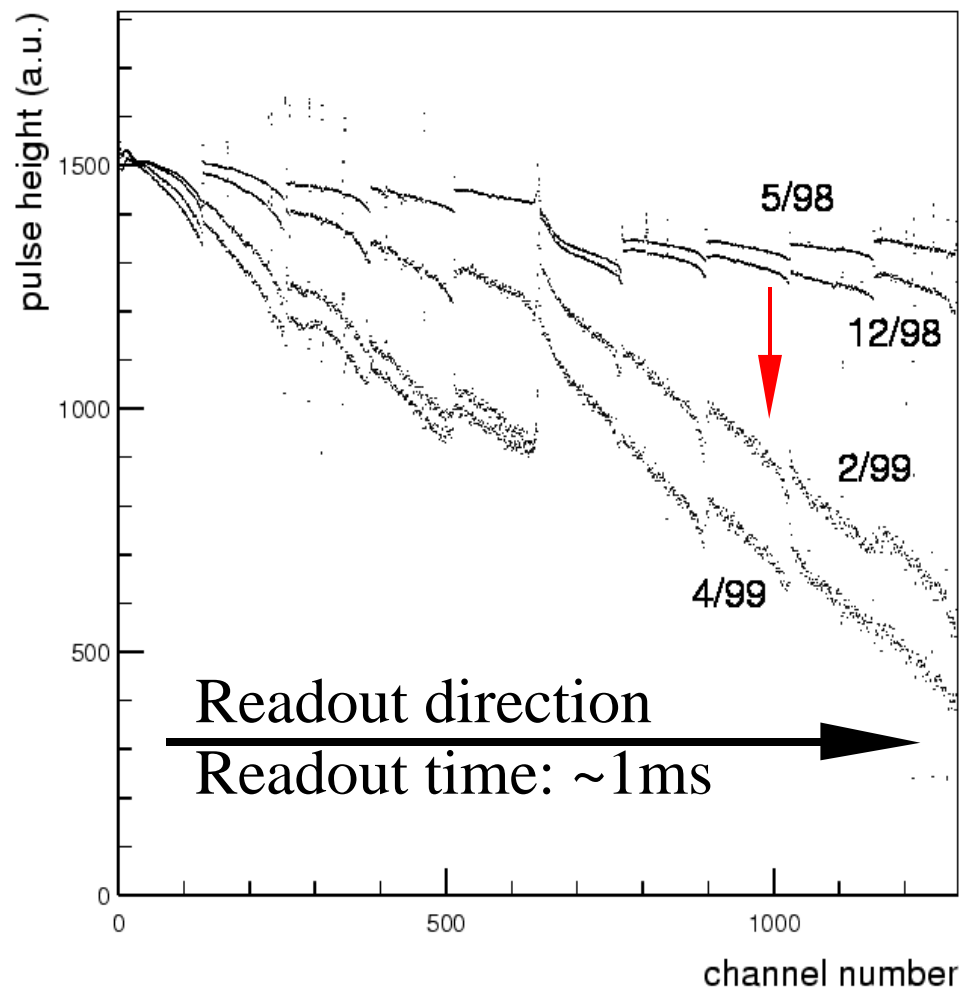
Radiation Damage

" Beginning of 1999:
about 25krad Synchrotron-
Radiation received

" Problem: Internal leakage
currents in the readout chip
are accumulated during
readout time of ~1ms

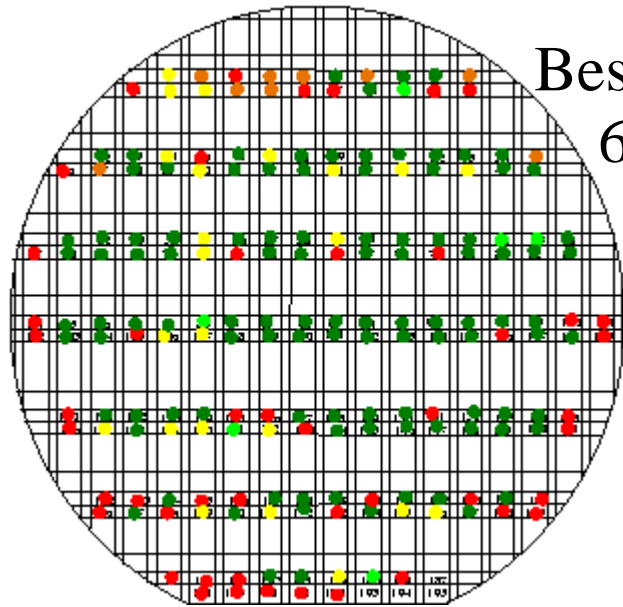
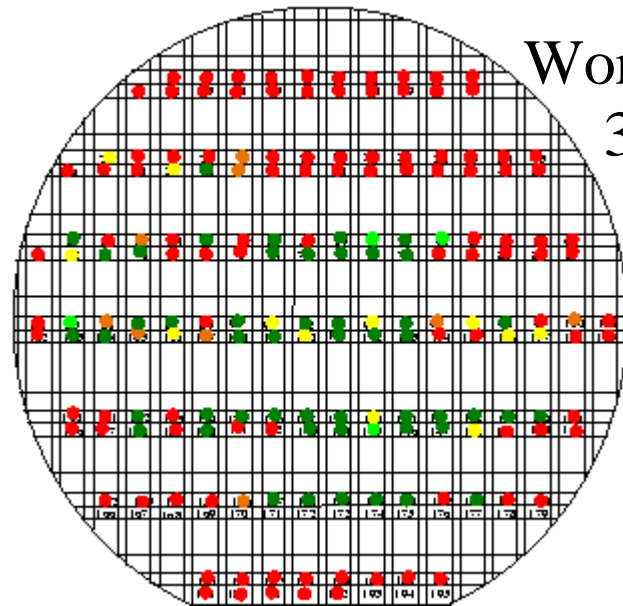
Yield

- " Yield: 56% for all 5 wafers
- " Varied between 37 and 69%
- " Accept 1 defect channel out of 128, or several defect buffers out of 4096
- " Biggest problem:
Defect dynamic shift registers
- " Leakage currents on chips?●

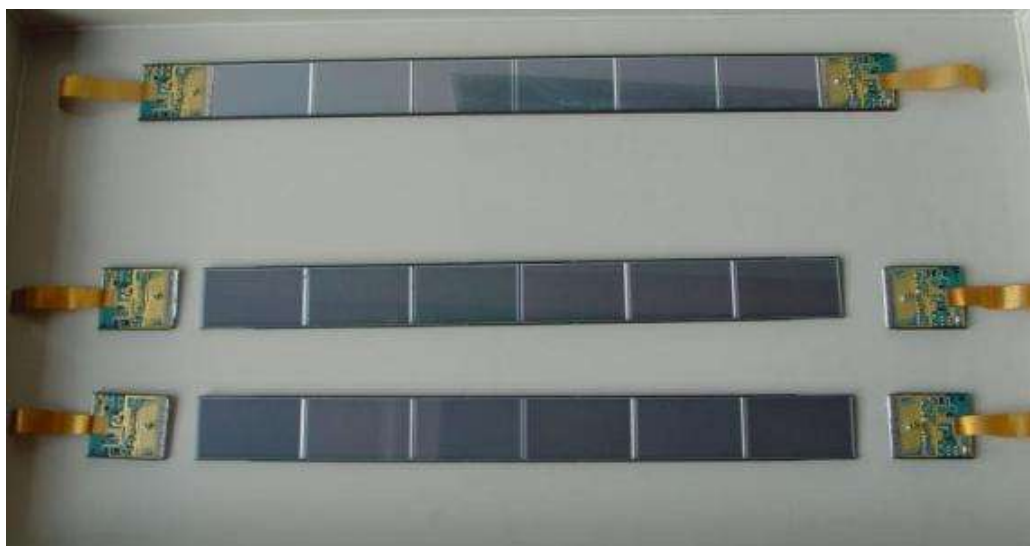
Reusing the Silicon

- " Goal: Replace the frontend readout chips
- " Sever readout hybrid from silicon
- " Remove 1280 bonds for each hybrid:
 - glue bonds to readout chip on hybrid
 - tear off hybrid: 95% of bond wires go off
 - bond pads generally not reusable

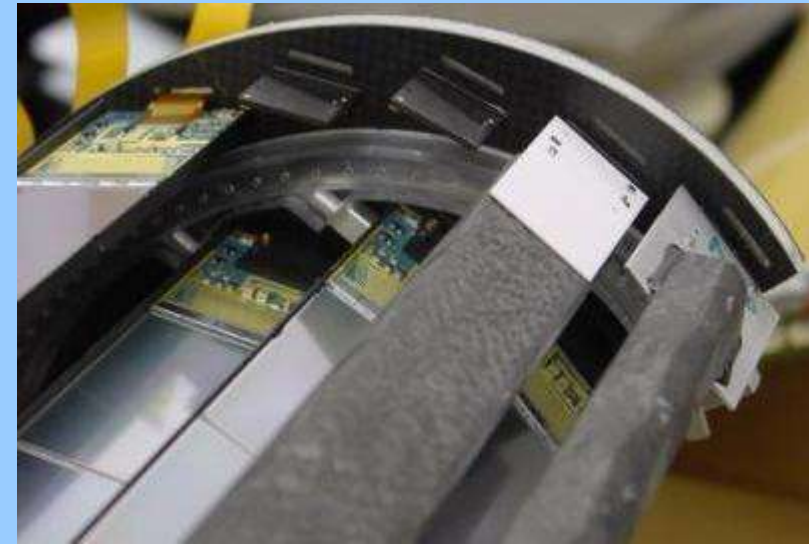
During assembly, dummy »ladders« are replaced by the real ones

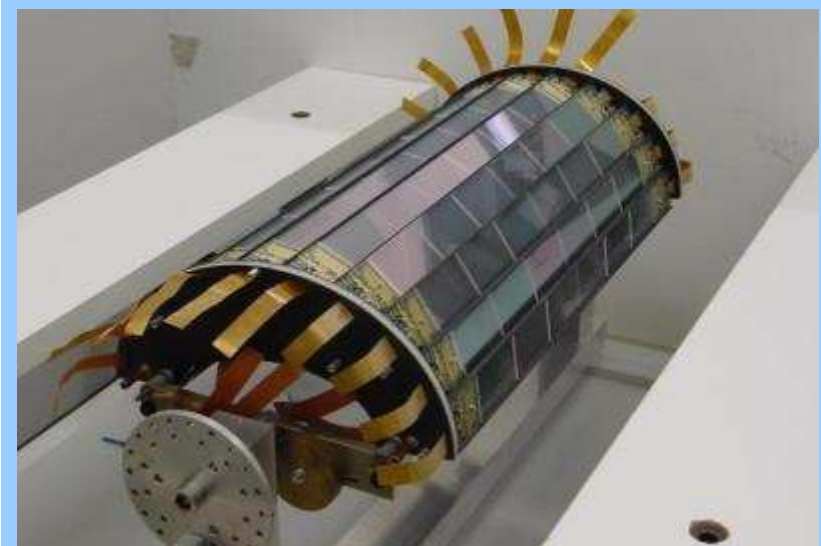
One half has been assembled

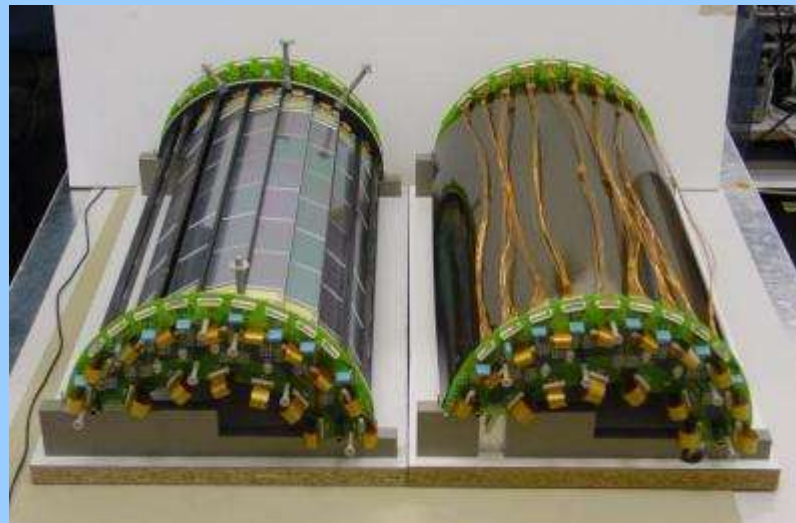
Both halves assembled; on right:
power cables from back to front
